Scraggs Bank, Newent

Summary Report to Newent Town Clerk

5th March 2024

Drafted by: **Newent Neighbourhood Flood Association (NNFA)**

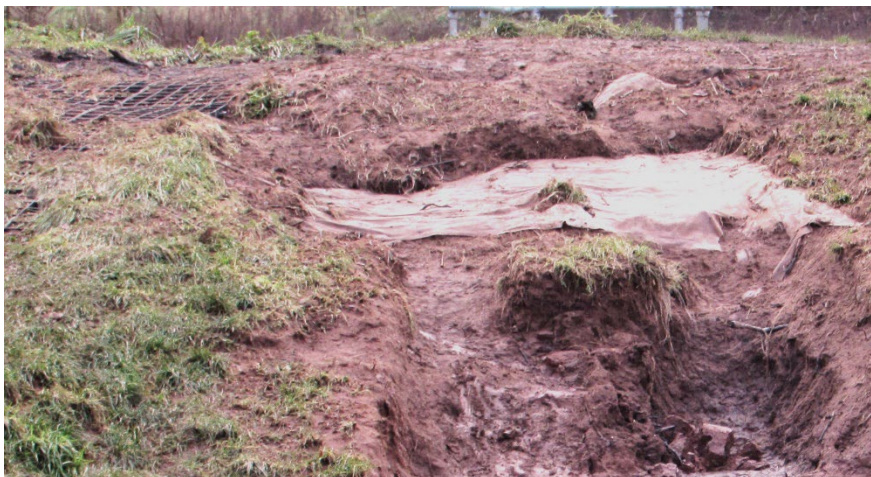
Our local residents have advised us that the bund actually overtopped prior to first grass seeding taking hold after construction and as such washed away a significant top layer.

This top layer was repaired by FODDC but not with the designed spillway. The opinion of NNFA is that the repair has left a weakness in the bund surface such that each time it overtops it scours more material. (such scouring has been dismissed by FODDC as due to ‘animals or vandals’ but it is evident by the photographs and eye witness accounts record water damage)

1. Reinstating the as-designed spillway to control overtopping speed and volume;
2. Constructing a second outfall pipe of the same diameter above the original to act as a controlled over-spill;
3. Inserting a second trash screen upstream to reduce the blockage frequency at the outfall pipe.

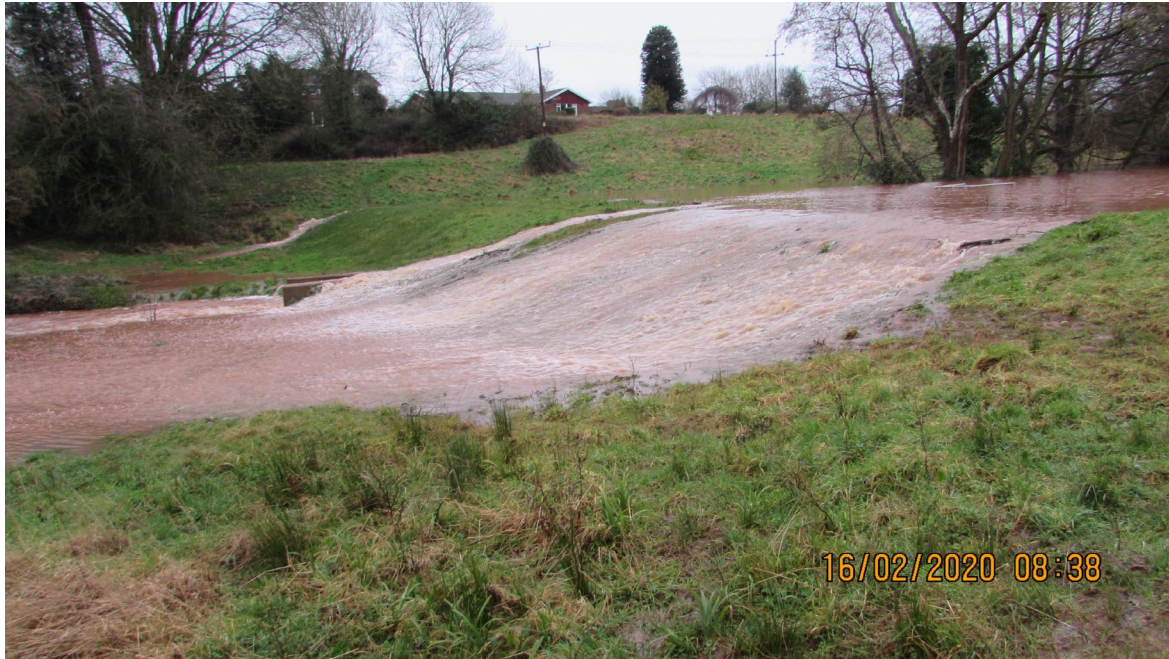
As a further example, in Feb 2020 a similar overtopping had occurred. See photo below.

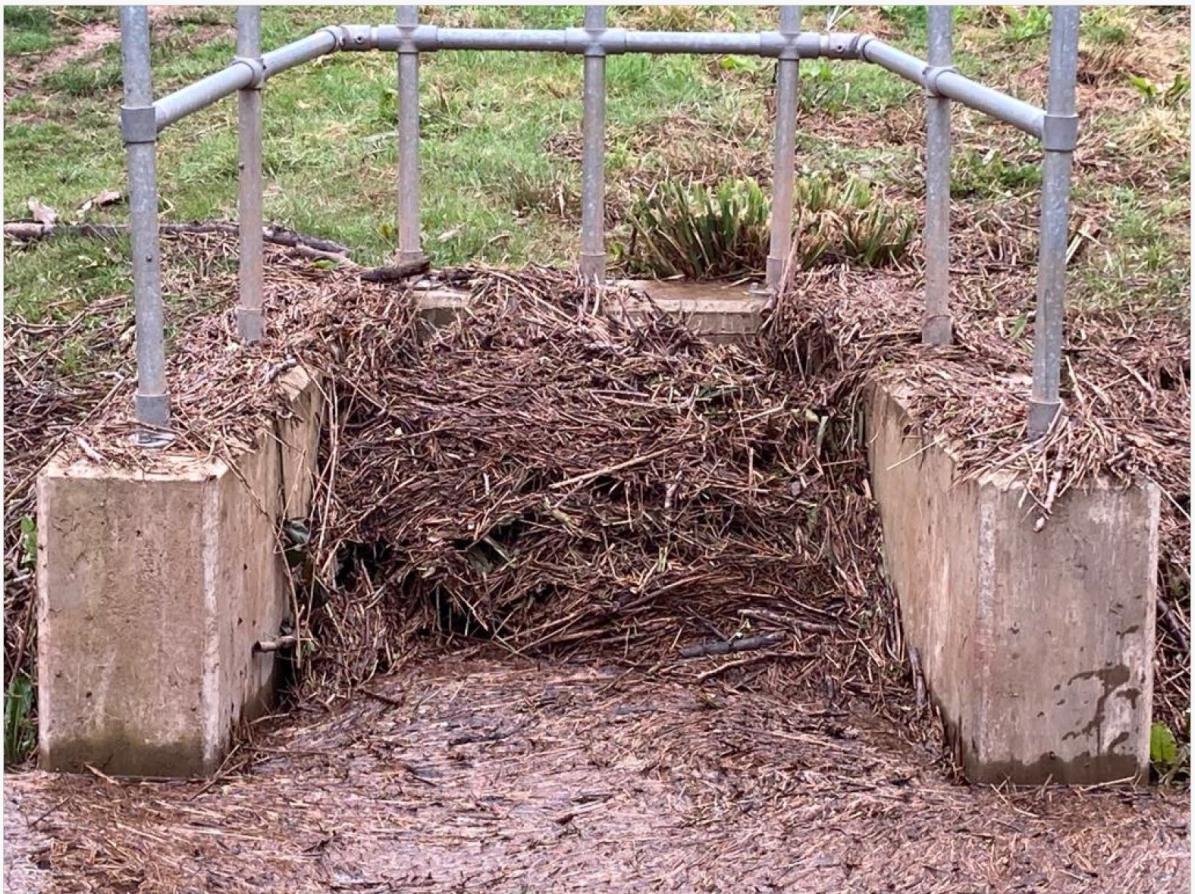
FODDC flood lead has advised that the clearance protocol for the trash screen is a 'reactive service' but it is unclear to NNFA as to what data or information is needed for FODDC to make such a reaction and clear the screen.

Nonetheless, and given the points made later regarding the woodland catchment and CIRIA screen re-assessment, it seems that a 'reactive service' in this case is ineffective and not sustainable in the long term.

It is also proven not to work as the screen has frequently not been cleared by FODDC at times of rainfall. In this case if the screen is not cleared prior to rainfall then operatives are unable to reach the screen because of increasing water levels.
