Scraggs Bank, Newent

Summary Report to Newent Town Clerk

5th March 2024

Drafted by: **Newent Neighbourhood Flood Association (NNFA)**

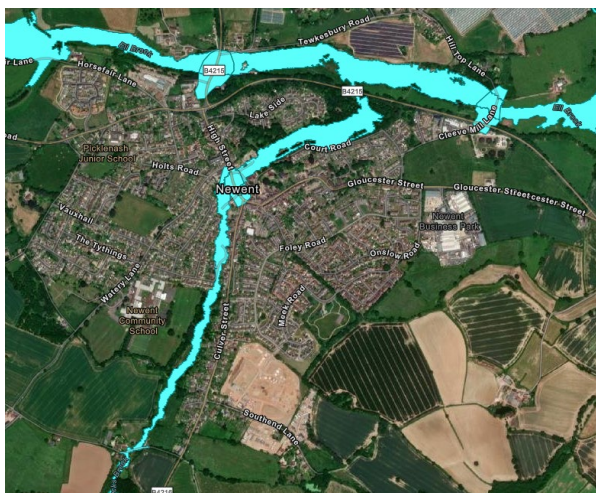
As can be seen from the Environment Agency flood mapping (figure 1) a large number of residences and several of the businesses and shops on Broad Street/High Street, the Lowell Street car park, the Library etc. are at risk of flooding and/or access restrictions. Thus the implementation of this flood resilience measure was welcomed by the town at the time of its construction.
